**FOCUSED SITE INSPECTION
SAMPLING AND ANALYSIS PLAN
FOR
UNITED RIGGING AND HAULING (MD-248)**

Beltsville, MD.

December, 2012

Prepared by: Maryland Department of the Environment
Land Management Administration
Land Restoration Program
1800 Washington Blvd., Suite 625
Baltimore, Maryland 21230

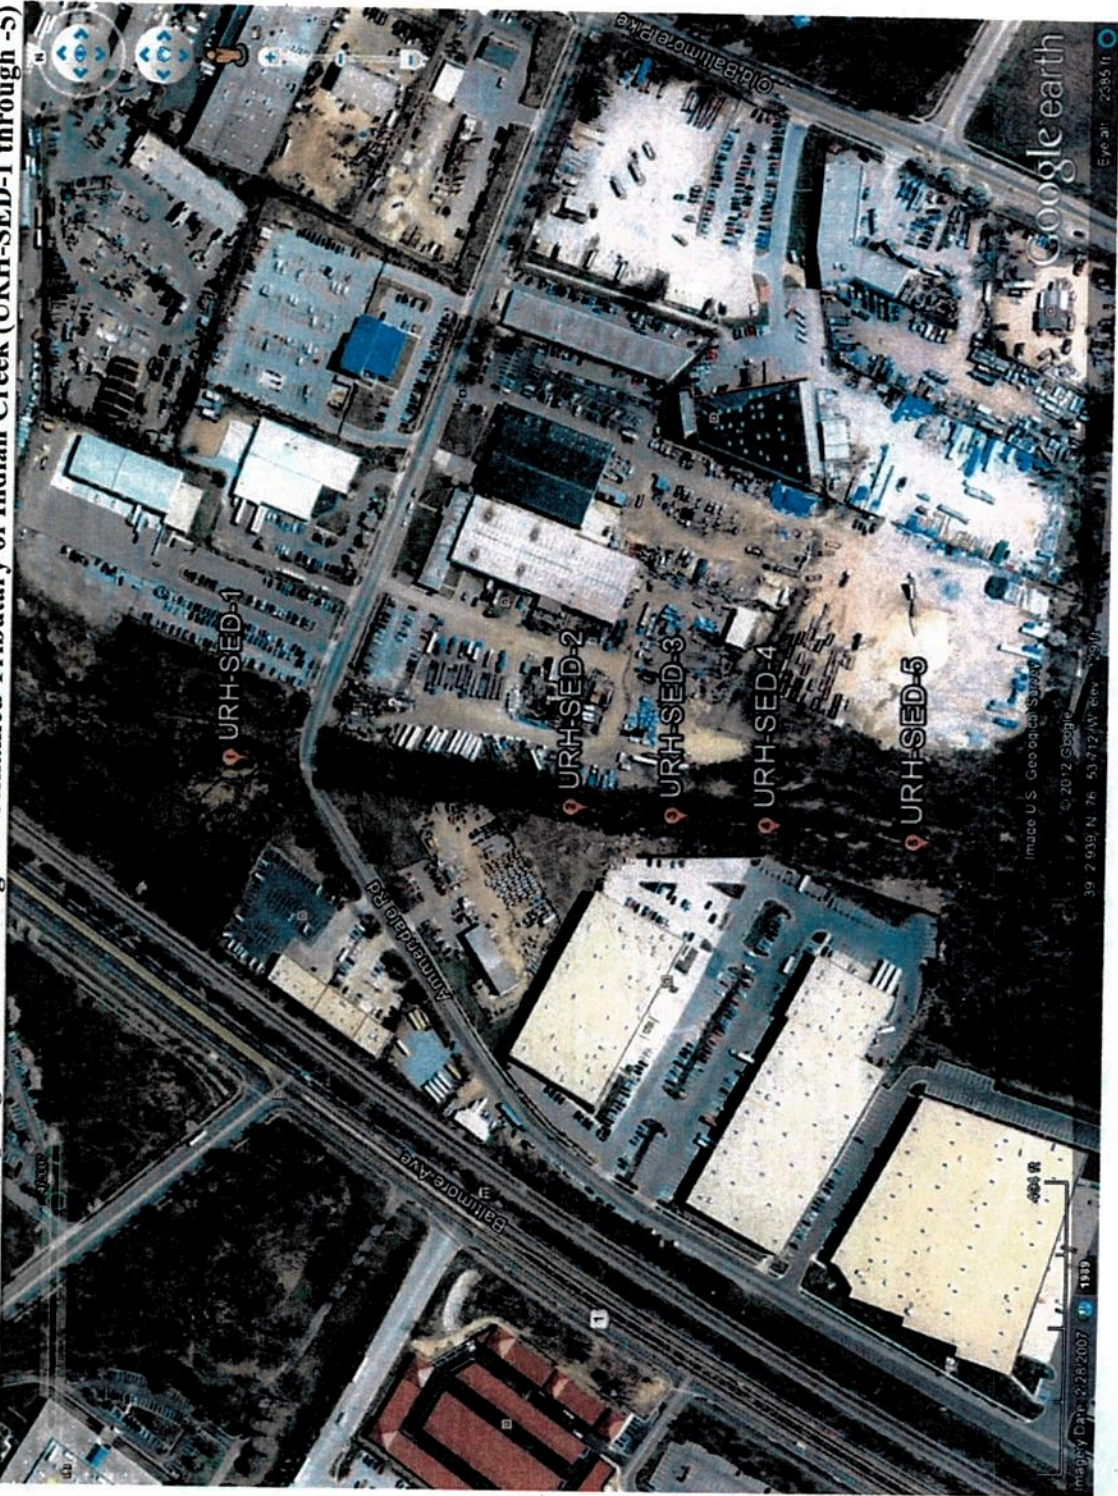
Figure 10a: Proposed Sampling Locations along the Unnamed Tributary of Indian Creek (URH-SED-1 through -5)

Sub-aqueous sediment samples will be collected from the unnamed tributary and Indian Creek via a disposable plastic scoop. Sediment samples URH-SED-1 through URH-SED-7 will be collected in the unnamed tributary of Indian Creek. URH-SED-1 will be collected upstream from Ammendale Rd to characterize the background sediments. Sediment sample URH-SED-2 will be collected near the discharge area of a sewer outfall which may act as a PPE. Sediment sample URH-SED-3 and -4 will be collected in the stream section west of the URH site. URH-SED-5 will be collected near the drainage from a transformer stockpile which may also act as a PPE. URH-SED-6 will be collected upstream from the Recover One Towing & Recovery Company to characterize sediments before potential impacts by the recovery company. URH-SED-7 will be collected near the confluence with Indian Creek downstream of the recovery company to characterize potential impacts on the unnamed tributary from the recovery company.

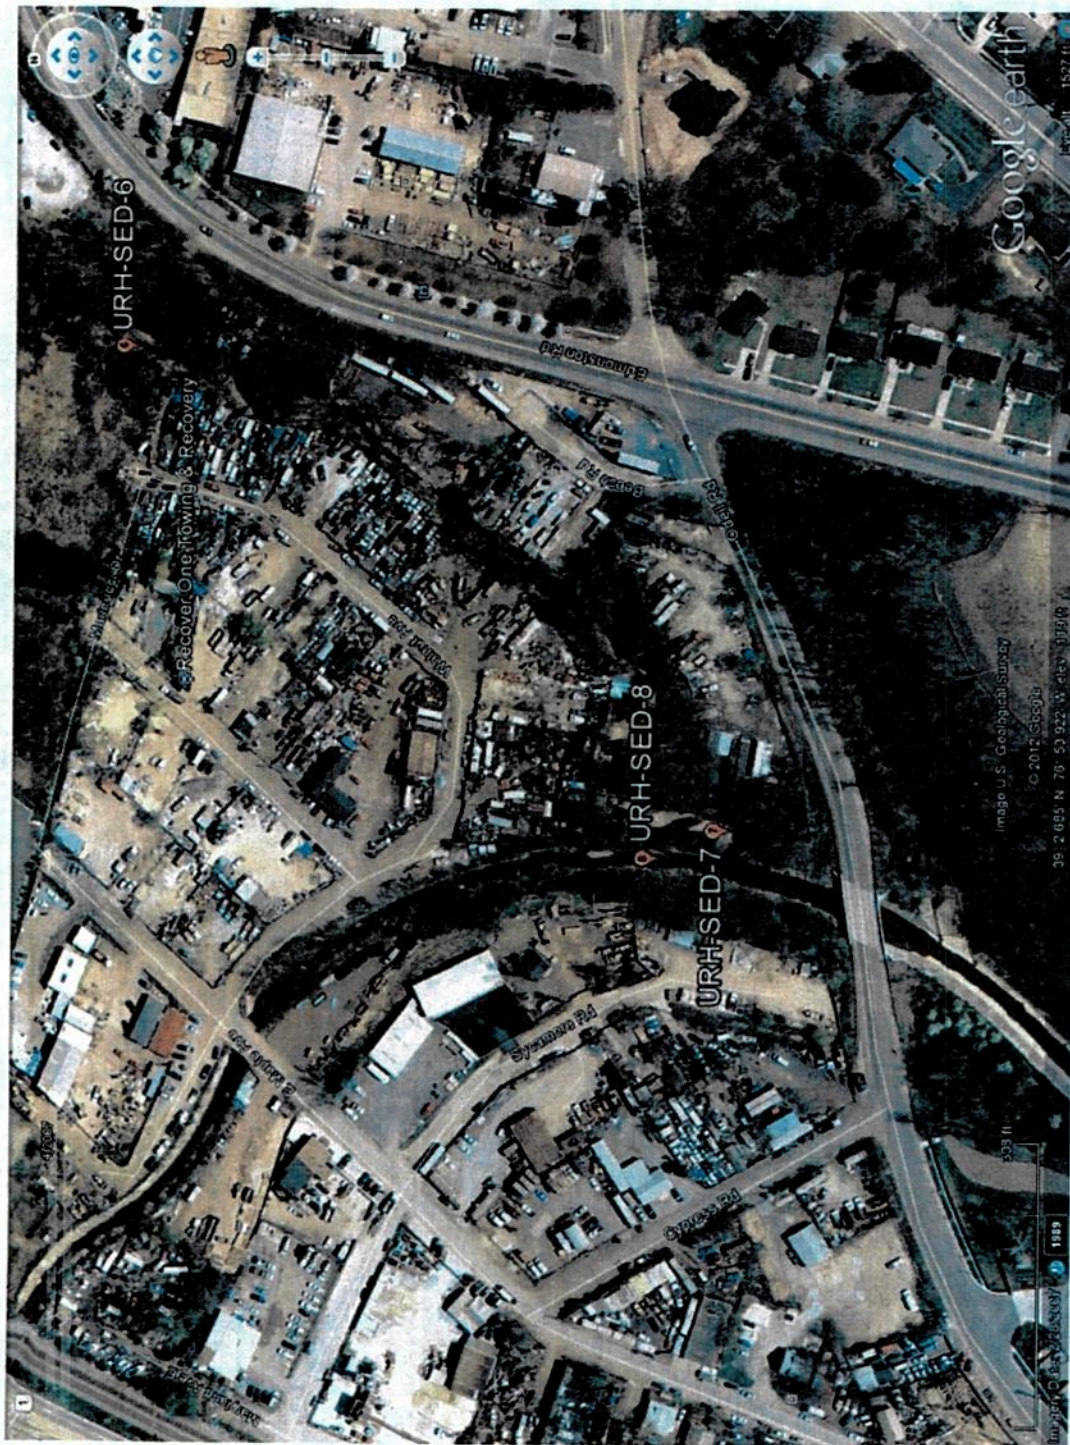
Figure 10b: Proposed Sampling Locations Near Confluence of Indian Creek and its Unnamed Tributary (URH-SED-6,-7, -8)

Sediment samples URH-SED-8 through -12 will be collected from Indian Creek. Sediment sample URH-SED-8 will be collected upstream from the confluence with the unnamed tributary to characterize the sediment in Indian Creek prior to any impacts from the unnamed tributary. URH-SED-9 will be collected downstream from Old Baltimore Pike. URH-SED-10 will be collected upstream from Powder Mill Rd. URH-SED-11 will be collected upstream from Sunnyside Ave. URH-SED-12 will be collected upstream from the confluence of Beaverdam Creek to characterize that portion of Indian Creek prior to potential impacts from Beaverdam Creek. URH-SED-13 will be collected from Beaverdam Creek upstream from Edmonston Ave to characterize the sediments in Beaverdam Creek that may be impacting Indian Creek.
